What measures were taken in nuclear power plants after the accident?

At the time of the accident in Fukushima Daiichi Nuclear Power Plant

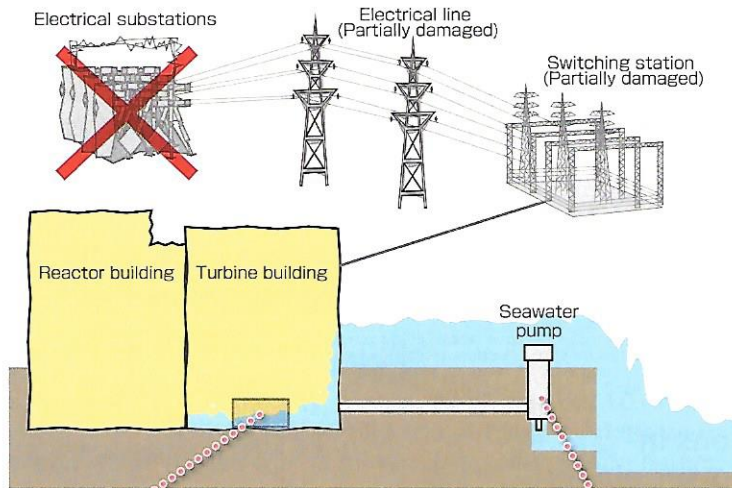
Facilities including electrical substations were damaged by the earthquake, and the supply of electricity from the outside was discontinued.

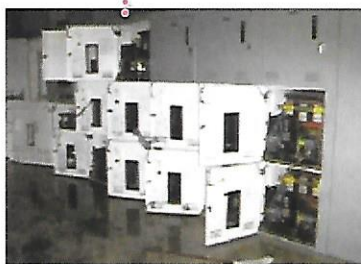
Immersed distribution boards

Water entered the buildings and the distribution boards became submerged. The electricity required for the operation of pumps and valves could not be supplied.

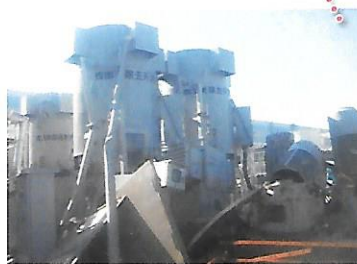
Seawater pump damaged by tsunami

The tsunami rushed into the site. The seawater-pump motor was covered by water and became unusable.
